RESTO HERO

'It was condemned by a professional restorer'

Bought as a wreck for £150 and working on a budget, Will Goldsmith turned his Alpine GT into a concours challenger

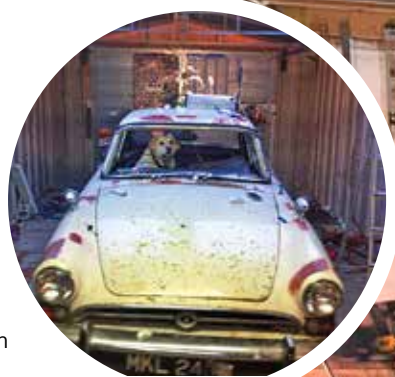
ABOVE The Alpine as it was found – very crusty!

Now the welding began, with every panel from the Alpine's waistline down having the rot cut out then new metal hand shaped and let in. Front wings and sills were available but at the rear, Will needed to fashion his own repair panels before welding them in place and grinding the welds back until they were nice and smooth. The industrial-size bottle of MIG shielding gas at the back of his garage testifies to just how much metalwork was needed. The body repairs took over three years, more than half the total project time. Asked if he ever found the restoration too daunting, Will recalls: 'The welding

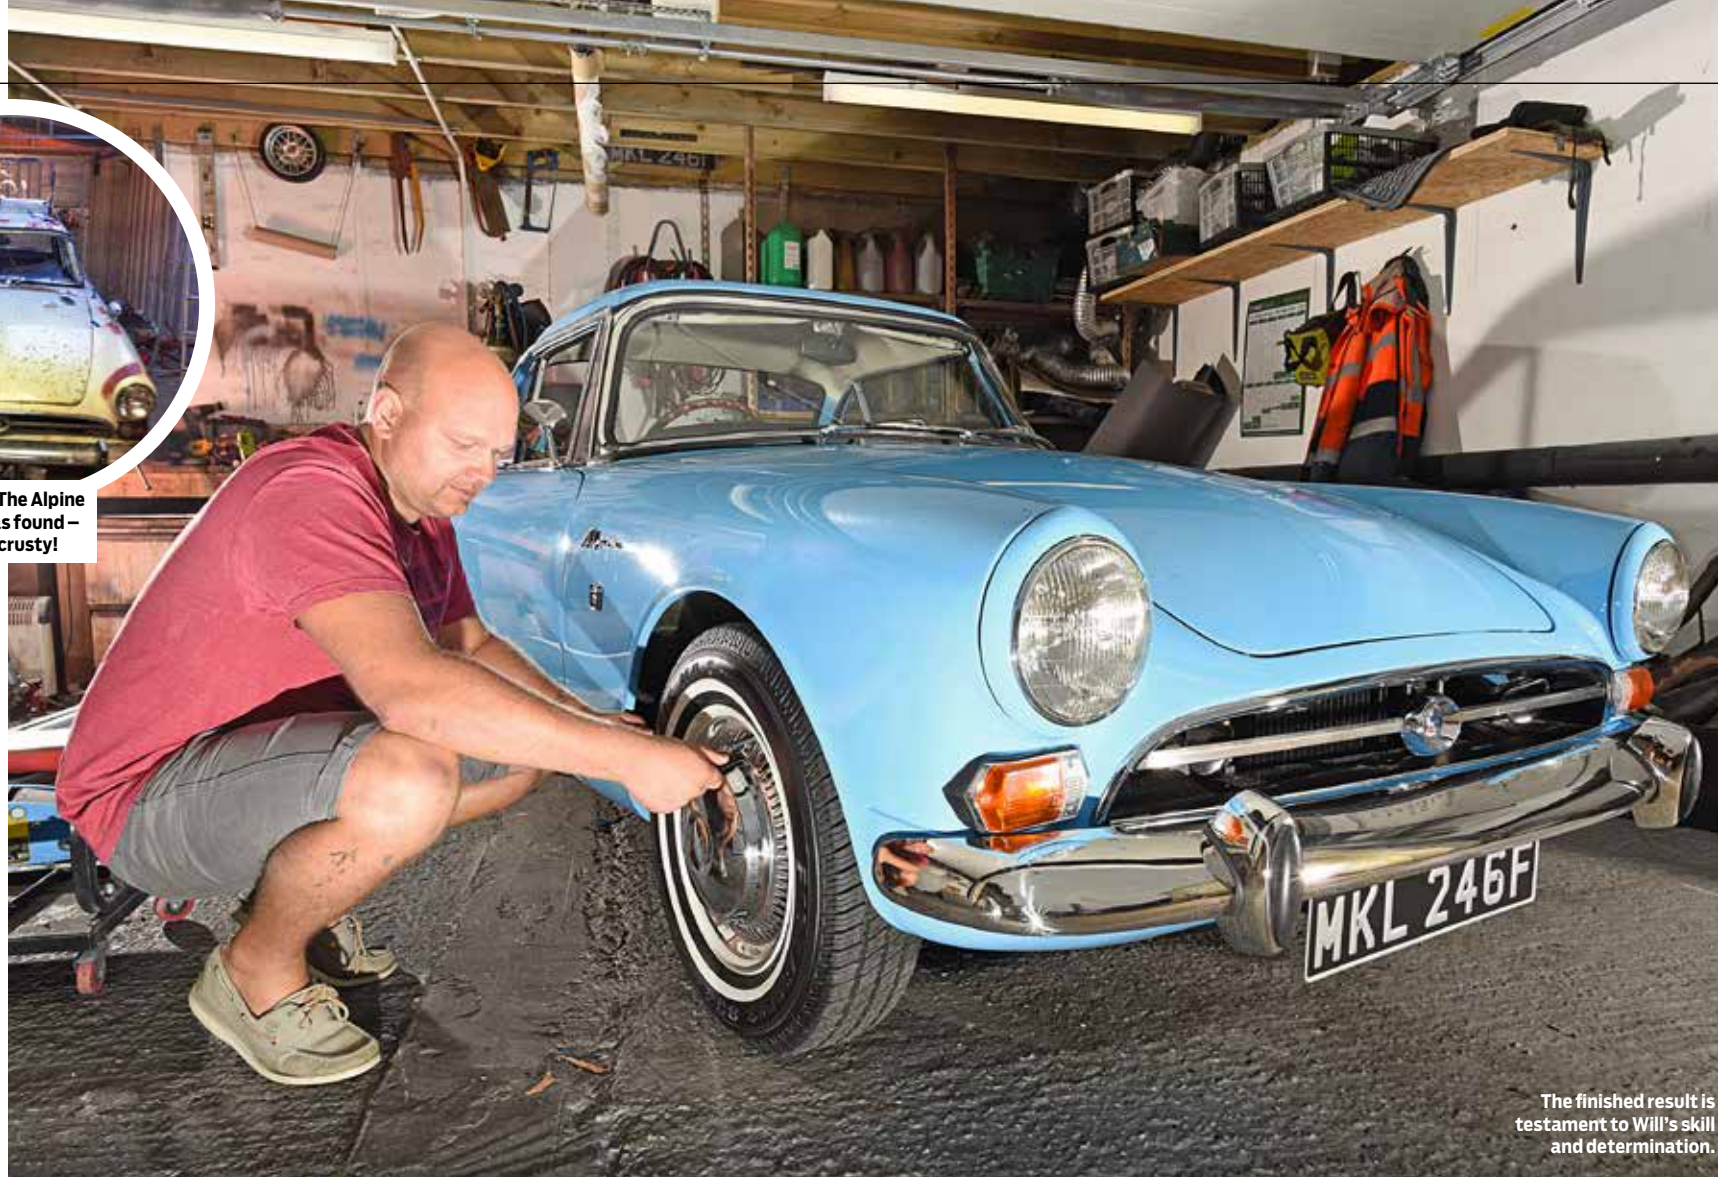
The finished result is testament to Will's skill and determination.

RIGHT Retrimmed interior is as fresh as the day it left the factory back in 1968.

BOTTOM Five coats of lacquer mean that steering wheel looks amazing.

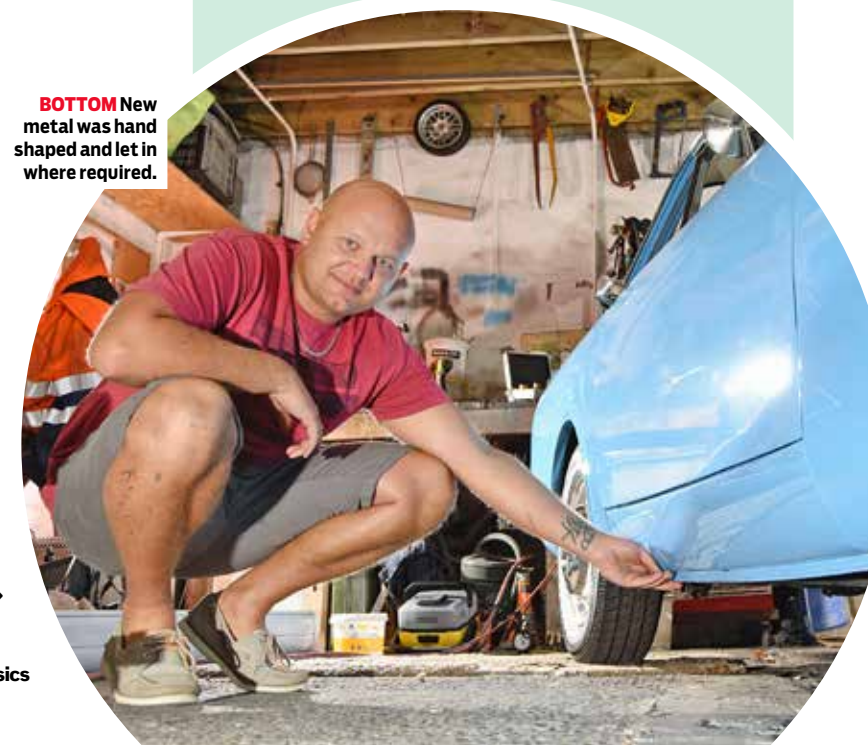
BOTTOM New metal was hand shaped and let in where required.
